## Bringing back the grandeur: conversion of Kom Tong Hall to Dr Sun Yat-Sen Museum

Eddy S T Leung, Wing-fai Lai, Evita S Yeung\* and Shing-wai Chan

Central Conservation Section

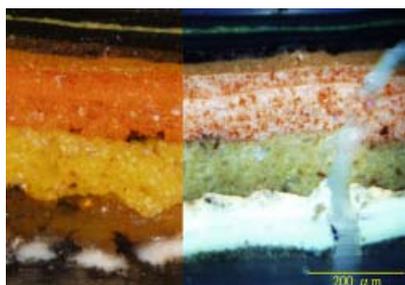
Figure 2. Cross section of paint stratigraphy from the balustrade under visible light (left) and ultra-violet fluorescence (right)

The key to making a sensible and informed decision on the material selection for the surface finishes is therefore to identify the original materials and techniques used on the metal balustrades. To this end, extensive technical analyses by X-ray fluorescence spectrometer and scanning electron microscope on the old paint remaining on the metal surfaces were carried out, (Figure 2) yet the on-site search for gold element using the former<sup>2</sup> was negative.

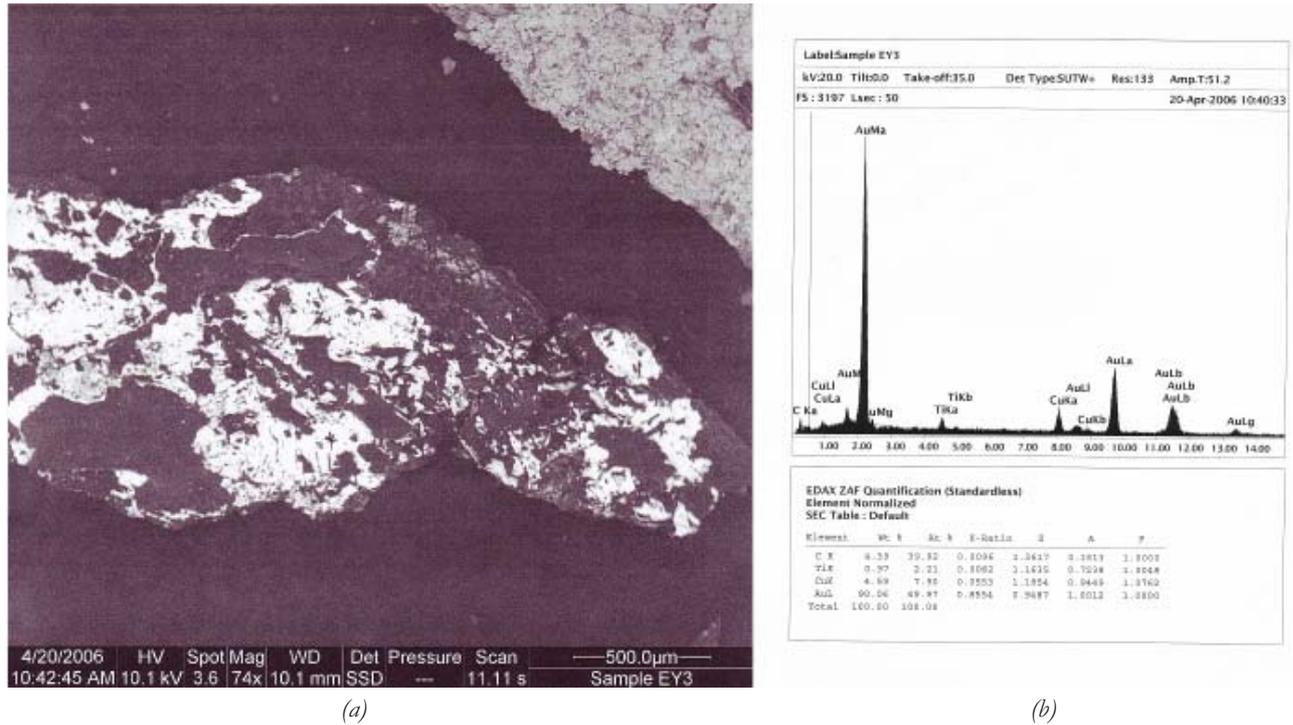
To complement the research, the surface paint samples, both scrapings and cross-sections collected from the balustrades were analysed in greater detail with a FEI Quanta 200 scanning electron microscope, equipped with an energy dispersive X-ray spectrometer<sup>3</sup> (SEM/EDS). Thirty samples from various parts of 14 metal balustrades on both the first and second floors were examined at 10–15 kV, at high vacuum with a back scatter detector. The samples were not sputter coated as there was no charging observed on the paint layer of the cross-sections by using high scanning rate and not very high voltage. Traces of gold element were found on five of the samples belonging to the surfaces of the floral decorations and the letter carving 'H' on the metal balustrades. These results clearly indicated that the surfaces of these decorative features were originally gilded gold (Figure 3a and b).

Figure 3a&b. SEM/EDS result for paint sample from plant decoration on a balustrade at Kom Tong Hall

The evidence derived from the above technical and analytical studies leaves no doubt as to the fact that gold gilding was applied originally to generate the glittering appearance of the building. These findings had in effect rendered changes to the original restoration plan, and both the architect and the curator

therefore agreed to re-gild the concerned areas in light of the guiding principle not to alter the historic condition of the built heritage. As a result, the original surface was reconstructed.

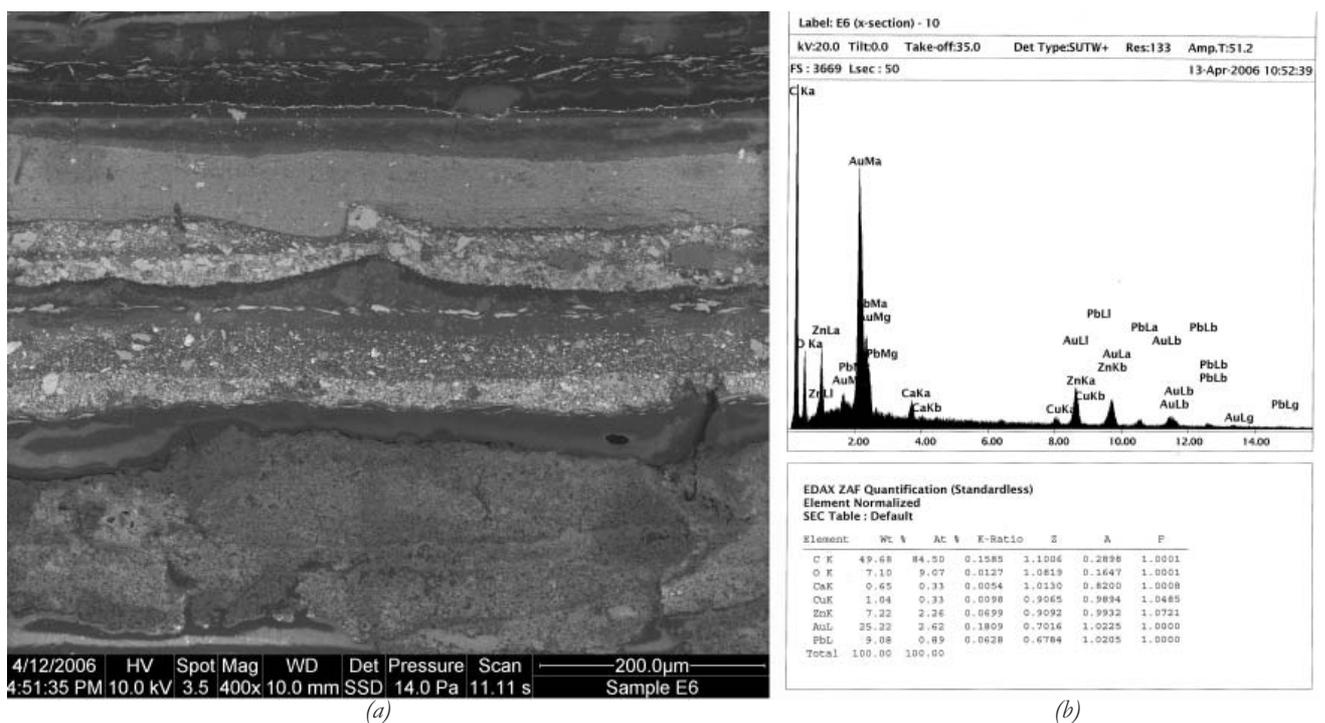
revealed that there was an abundant quantity of gold gilt in all the samples collected from the mouldings at the ceiling or colonnades (Figures 4a and b, 5). It was evident that plaster was used as the ground substrate under the gilded surface and the workers had not removed the old gold gilt finishes before applying the new paint during previous renovations in order to avoid damaging the plaster mouldings.

Figure 4a&b. SEM/EDS result for sample from moulding at the ceiling of the main hall at Kom Tong Hall

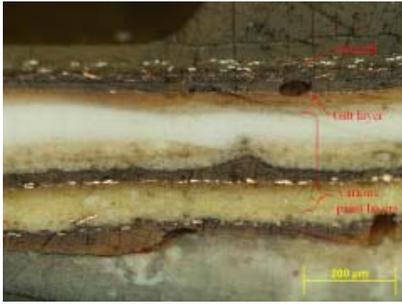
Figure 5. Cross section examination under Leica MZ6 reflective microscope (see the scale on figure for the magnification) for sample from moulding at the ceiling of the main hall at Kom Tong Hall

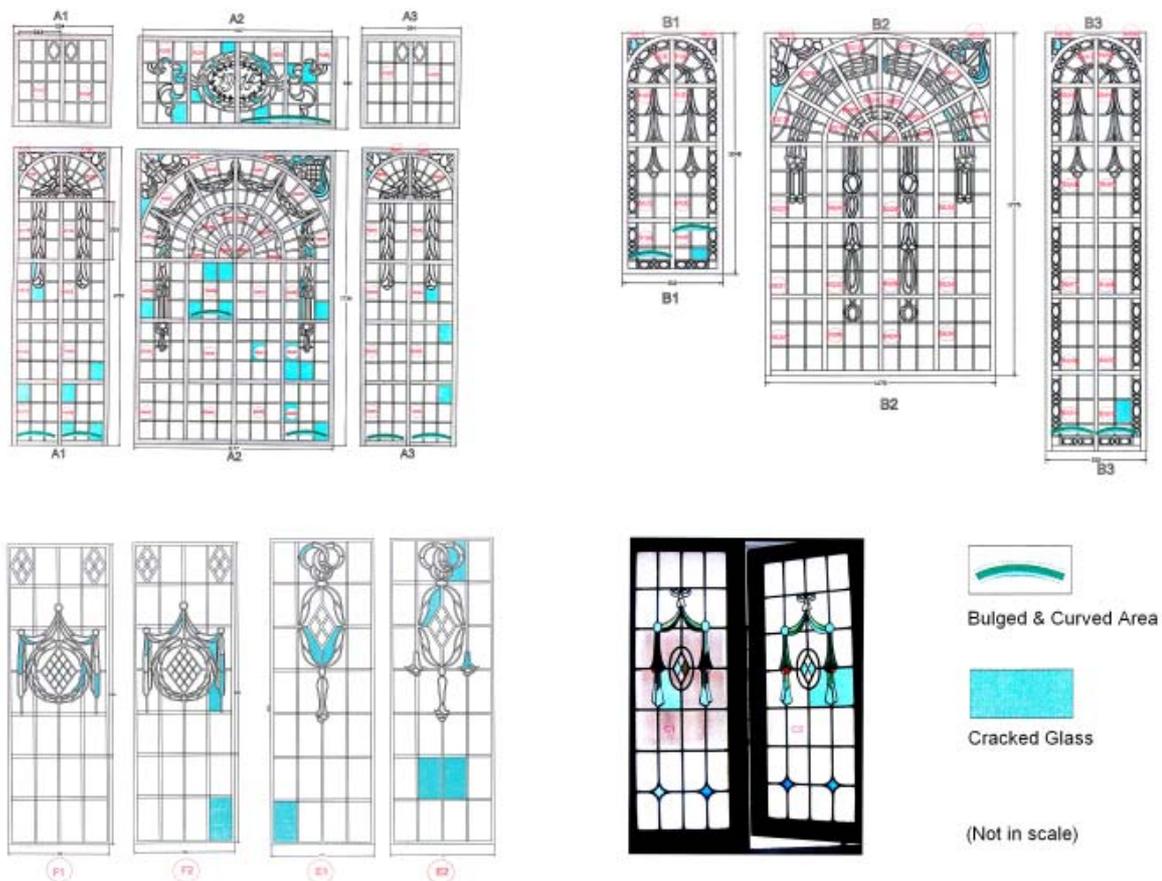
There are a total of 18 stained glass windows in Kom Tong Hall. After a span of some ninety years, a good number of the composite glasses were cracked with losses in some areas, the steel framework had generally corroded, and some of the lead came were damaged or deformed causing planar distortion to the window. Except for the four missing windows which had to be replaced with new replications, Figure 6a–d showed the extent of damages found in the rest of the 14 stained glass windows.

Figure 6a–d. Result of the condition survey on the stained glass windows in Kom Tong Hall conducted in August 2006

Given the inferior quality of the lead comes and the unsatisfactory condition of the glasses, the architect preferred to replace the windows with replicated ones for the sake of work convenience and public safety as, besides the aesthetic reason, the replacement windows should be strong enough to stand the wind and rain attacks. Nonetheless, the conservators did not agree with the idea of total replacement unless the glasses were missing or substantially damaged. In consideration that the stained glasses and the old lead comes were the original elements of the building and that the corrosion was merely localised on the surface of the comes as revealed by the examination of their cross-sections, the conservators were of the view that the original stained glass windows should be preserved as far as possible. The replacement windows made of new lead comes and modern glasses would not attain the same aesthetic quality as the works of an earlier century and the extra replacement would result in the loss of substantive evidence concerning the construction and fabrication technique of historic stained glass windows. In response to the concerns of the architect and the curator that consolidated or restored stained glass windows might not be strong enough to meet their functional role, it was agreed that the consolidation and repair work for the damaged stained glasses and lead comes would be performed by the conservators instead of the renovation contractors, but those seriously cracked glasses with considerable missing parts would be replaced by new replications.<sup>4</sup>

The windows were then taken down in sequence for treatment in the conservation laboratory and the broken comes were rejoined by soldering.

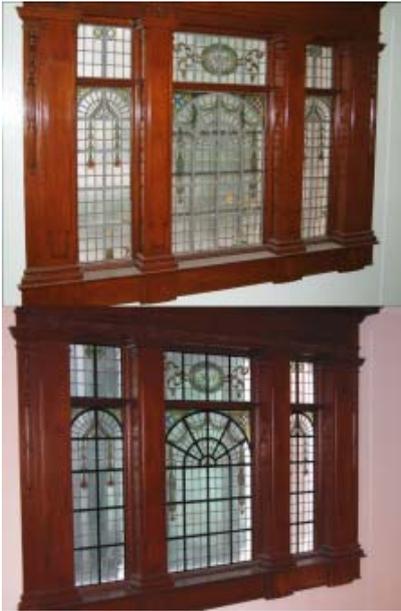
Figure 7a&b. Stained glass window before and after conservation

Having considered the aforesaid factors, the conservators managed to convince the architect and the curator to agree with the use of this traditional material for restoring the stained glass windows, and finally the effect of the treatment work was highly regarded by all the parties, including the previous owners of the building, the architect and the curator while maintaining traditional physical properties and techniques (Figure 7a and b).
