## Strike a Balance - Repair or Replace?

Chik Kwai Study Hall, a typical traditional Chinese study hall in Hong Kong, was built not later than 1899 by Lai clan in Sheung Tsuen, Pat Heung, Yuen Long. It was originally built for the education of young clansmen and had been used for ancestors worship since 1930s. It also served as a venue for holding clan meetings and traditional rituals, such as wedding ceremonies and ancestors worship at spring and autumn equinoxes.

Chik Kwai Study Hall was gazetted as a monument in 2007, and was in a state of bad disrepair. To preserve this valuable historic building, a full restoration programme has been carried out since 2009. After restoration, the building would be open for the public to appreciate its exquisite features and hence the local history and cultural heritage of the area.

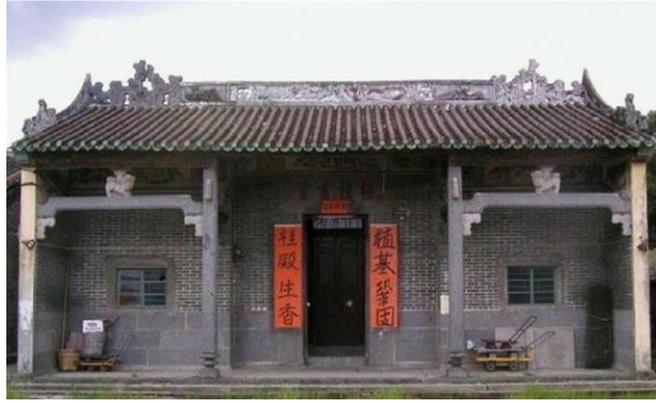
Fig. 1 Front view of Chik Kwai Study Hall before restoration

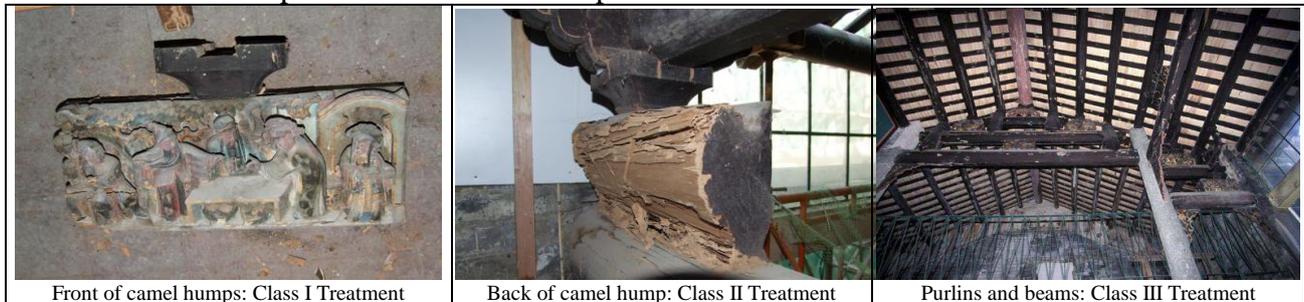
Being constantly affected by the adverse sub-tropical climate, the century old Study Hall was in an alarming state of deterioration when our conservators were enlisted to provide technical assistance. Among other problems, its timber members of the structural frames supporting the roof were suffering from a range of problems -- the biological growth and surface contamination of the wood materials, loss of pigments due to weathering, and the worst of all, signs of extensive termites attack resulting in damage of figurines and collapse of the wooden structures. The problem was so extensive and serious that it was doubtful if all of these wooden structures could be preserved without compromising the structural stability of the Study Hall. A careful and detailed assessment must be carried out as these wooden components, such as camel humps were the key components of the whole structural system. They served to support the upper wooden beams and in turn the entire tiled roof.

For instance, the carved figurines in front of the camel humps are said to have attained a very high level of aesthetic merits and exquisite craftsmanship, reflecting on the cultural aspirations of the ancestors. Though the figurines had suffered extensively from termite attack, all the stakeholders agreed to accord Class I treatment to them so as to preserve these character-defined elements. On the

other hand, the back of camel hump depicting the engravings of some cloud patterns is nevertheless less distinctive or appealing when compared with the figurines in the front. In consideration of that very little fibres and strength have been left in this part of the wooden structure after the termites attack, they would be given a Class II treatment to re-generate the needed structural strength. And as an example of Class III treatment, the roof structure of the Study Hall had been subjected to serious termite infestation and its badly infested Chinese fir beams and purlins exhibited a high risk of collapse. In order to alleviate the immediate danger, this part of the structure which had no decorative elements on it was reproduced and refitted to position.

Fig. 2 Condition of wooden components before restoration

1. Class I - total preservation and retention, in which all the finest parts of relics should be consolidated and preserved as far as possible. They should be properly treated and reinstated to their original state and position after conservation.
2. Class II - partial replacement, in which replacement with replica would be carried out for non-critical parts, supplemented with consolidation of weaker original parts, to ensure the strength of them would be comparable to the original wooden structures.
3. Class III - total replacement, in which the badly damaged wooden structures would be replaced with new reproductions.

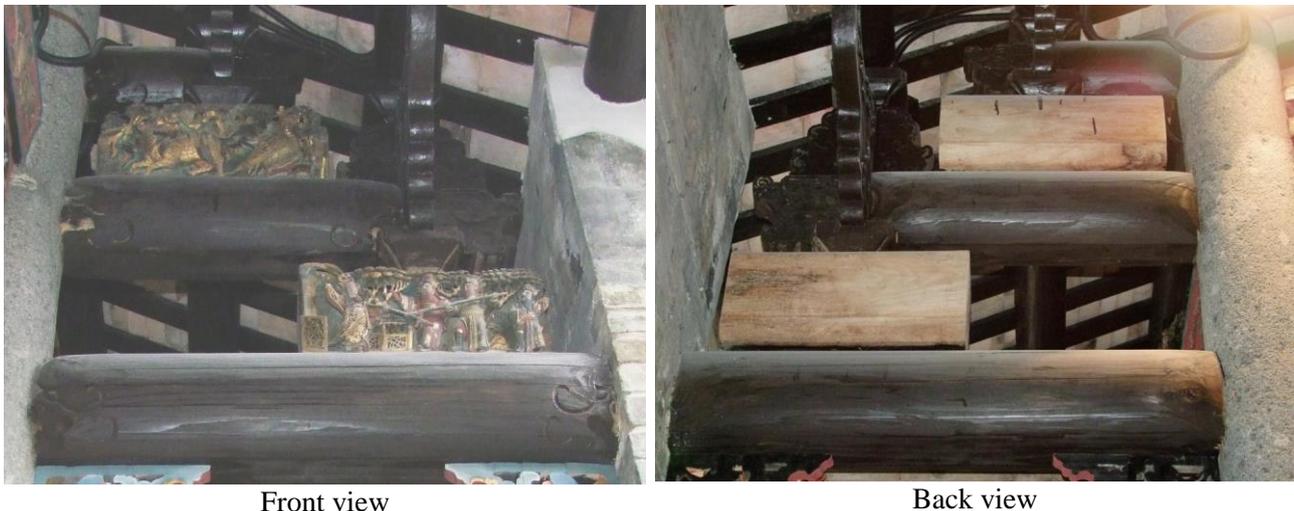
Front view

Back view

Fig. 4 Wooden camel humps after conservation

From the results, the hardness of WAP with addition of sawdust (78) is closest to that of the Camphor Tree (77) amongst the gap-fillers tested while the hardness of ER with addition of sawdust (71) is closest to that of Funeral Cypress (67). However, their tensile strengths are far lower than that of the two timber species. Therefore, EWE was selected as the gap-filler for the camel humps made of Camphor Tree as their tensile strength and hardness were comparable with each other while EWE with sawdust was selected as the gap filler for the 2 camel humps made of Funeral Cypress for the same reason. To achieve good compatibility between the consolidant and the gap filler, EWE was also employed as the consolidant for camel humps.

It was moreover noted that the addition of sawdust to EWE could reduce the hardness from 82 to 73 and tensile strength from 454.9 to 193.5mPa. These reductions are beneficial to its use in the restoration of figurines as it is then easier to carve or cut the mixture to conform with the original shape, curvature and profile of the figurines. Therefore EWE was applied as the gap-filler for camel humps made of Camphor Tree to form a stronger and harder inner core to support the structures, whereas EWE mixed with an appropriate amount of sawdust was used to form the outer layer of the gap-filling to facilitate the carving. This strategy has been successfully employed for the whole restoration process.

The decayed back of the camel humps was replaced in accordance with the Class II approach. Conservative pieced-in repair was used to replace rotten substrates with the same wood species. There have been two options to avoid the potential problems of deformation or shrinkage which might occur in the new replicated wood materials. We might either seek to find the same type of wood materials with comparable age and in the neighbouring region of the Chik Kwai Study Hall, or use the new timber of the same species after artificial seasoning. The first option is preferable as the properties of the wood should remain relatively unchanged over time if the identified wood materials have been kept dry and free from mechanical and insect damage (Senft J. F. 2003). The quantity of the available
